NEW RIVER DAM FOUNDATION REPORT GILA RIVER BASIN:
PHOENIX ARIZONA AND VICINITY (INCLUDING NEW RIVER) (U)
ARMY ENGINEER DISTRICT LOS ANGELES CA OCT 85

New River Dam Foundation Report

October 1985

20. ABSTRACT (Continue on reverse side if necessary and identify by block number) This report provides a complete and accurate record of foundation conditions underlying New River Dam and its appurtenances. The report also summarizes construction methods employed in excavating, preparing and treating the foundations; describes testing and explorations performed during construction and design modifications required by unforeseen site conditions; and discusses conditions which may require post-construction observation or treatment. Includes 64 plates.

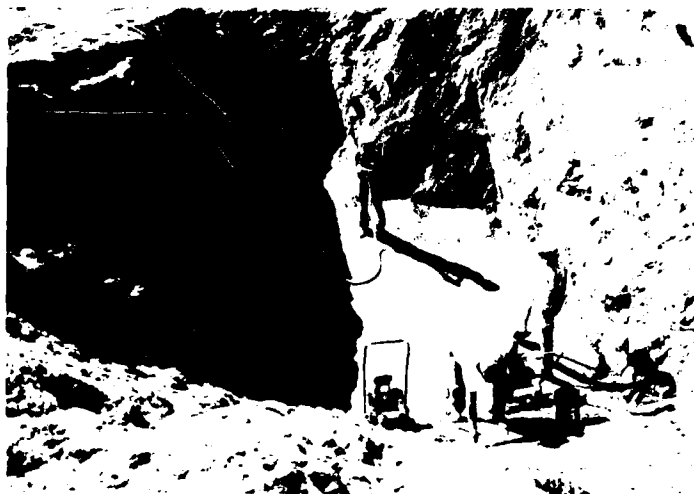
Photo 26. Backfilling foundation depression upstream of dam centerline between stations 14+85 and 15+25. 7 February 1984

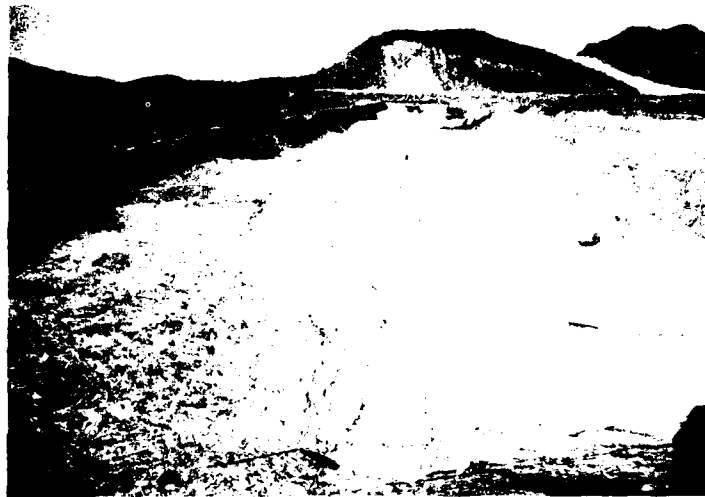
Photo 29. Looking west at core trench excavation from top of slope at station 16+40. Note major shear zone near upstream edge of excavation at right and smaller individual shears which criss-cross remainder of foundation surface. Contact between granite and diorite (in foreground) near center of photo. 29 March 1984

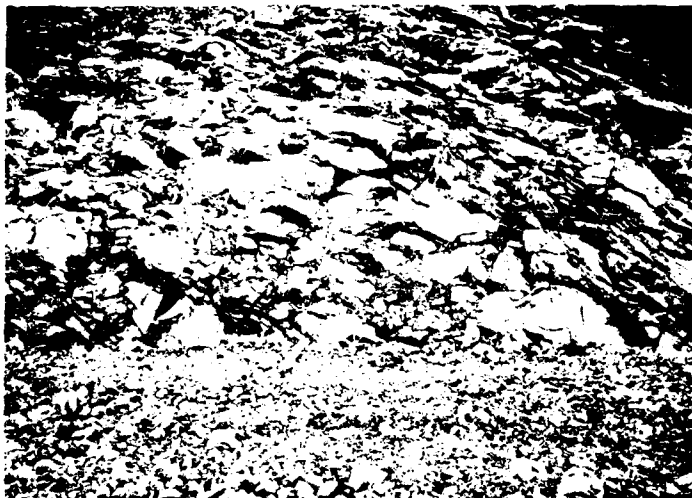
Photo 33. View of right abutment prior to start of Stage III construction. Note highly fractured, blocky nature of andesite rock mass and well-defined layering which dips obliquely upstream (toward lower right of photo).
26 September 1984

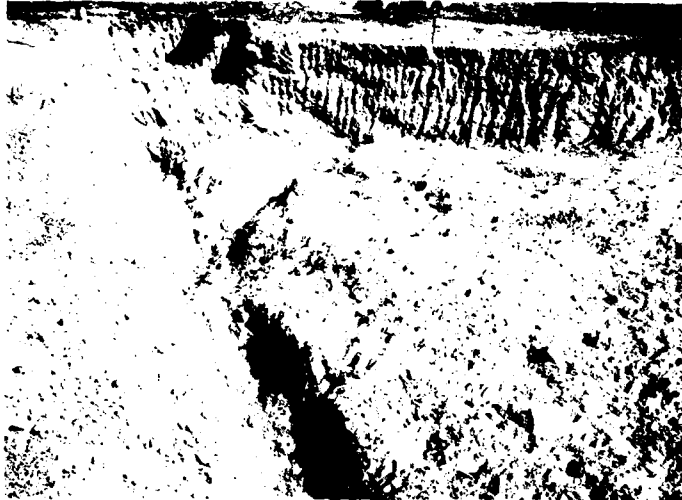
Photo 75. View of upstream end of intake structure foundation looking east. Note left side wing wall steps in background and shear zone extending across bottom of excavation. 6 February 1984

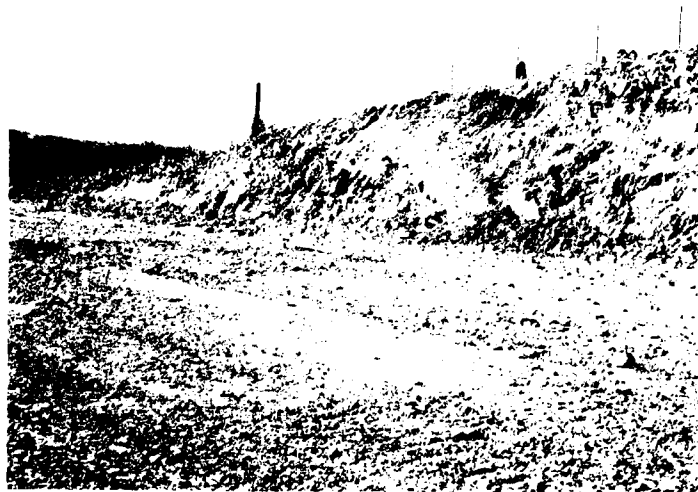
Photo 94. View of downstream north wall of completed spillway excavation showing layered volcanic sequence which dips 30°NE. Note massive flow breccia separating fractured andesite (on right) and tuff units. Alluvium exposed near edge of photo on left. 29 November 1984

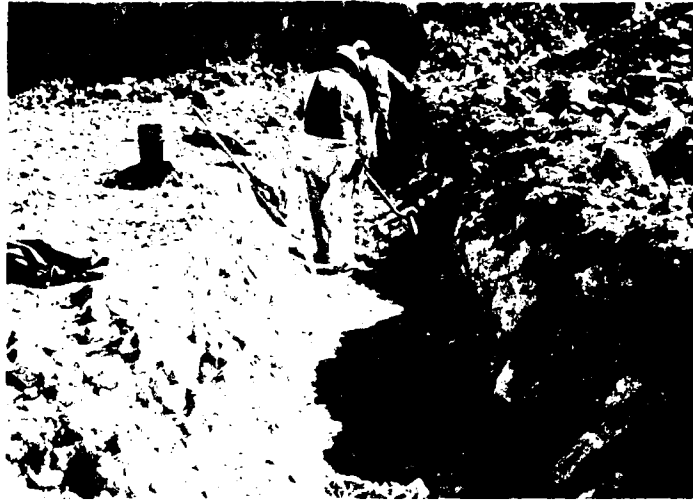
Photo 105. Laborers cleaning loose rock from invert section of spillway sill. Variable bedrock structure resulted in wider and slightly deeper excavation than originally designed. 29 November 1984

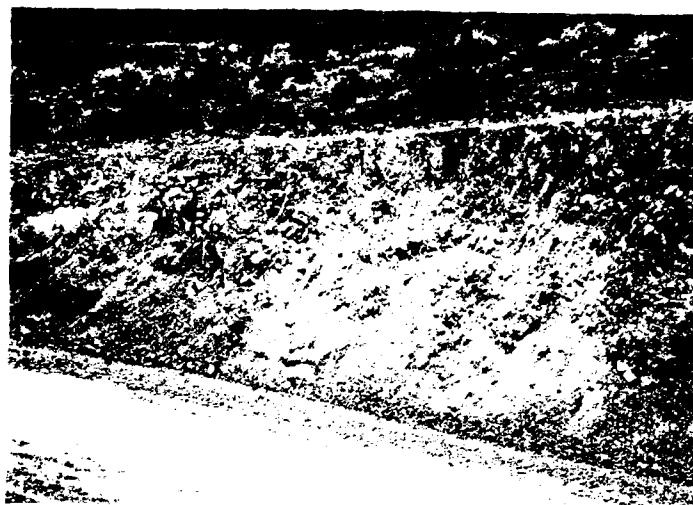
Photo 117. Slope failure in intensely fractured platy andesite, north wall of spillway excavation, vicinity station 14+00. 18 April 1985
